## Heritage at Risk – Conservation Repair Project at St John de Sepulchre Funders update, December 2020

Norwich Historic Churches Trust cares for and preserves 18 grade I listed, medieval churches in Norwich, which are no longer used for religious worship. They form an inextricable part of the cultural character of the city, as well as the medieval fabric for which Norwich is so well known.

One of these churches, St John de Sepulchre, was in dire need of repair and had unfortunately been classified as 'Heritage at Risk'. Of most pressing concern was the condition of the south vestry which was in an advanced state of collapse, risking damage to the adjacent medieval chancel. Other critical issues were the collapsing south east buttresses of the chancel, structural issues in the transept, failing roof coverings and general poor condition of flint work.

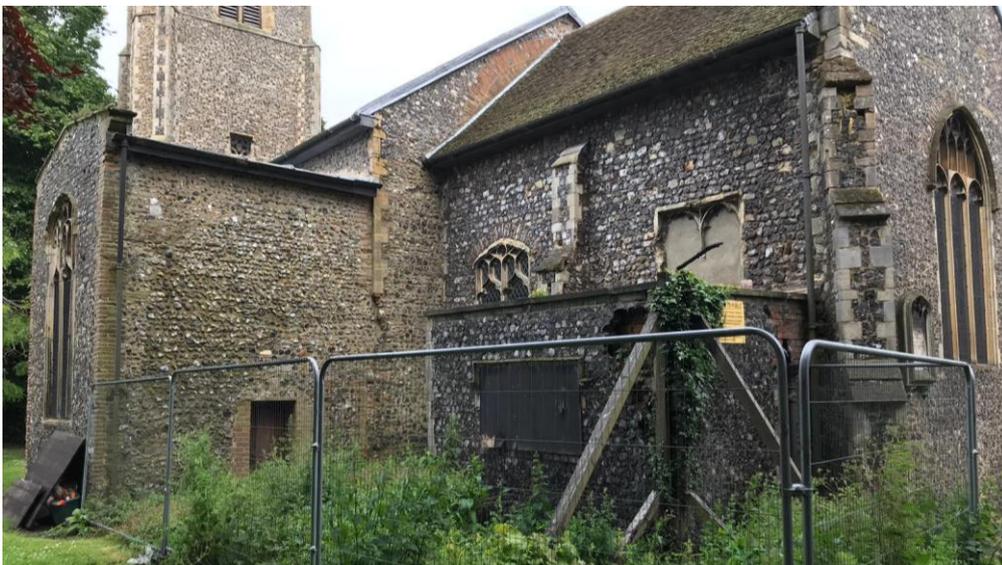
*Photograph showing the poor condition of the vestry, which is propped, with a barrier to ensure public safety*

Funding provided by Historic England, Norwich Historic Churches Trust and other local funders enabled a repair project to go ahead, the aim of which was to secure the building for the long-term future.

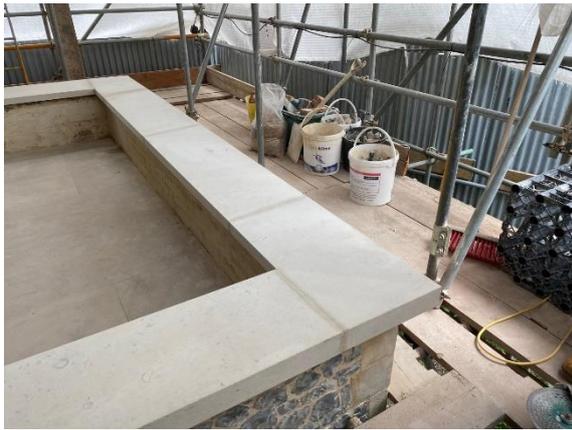
*New copings on the rebuilt vestry*

Total dismantle and rebuild of the south vestry (reusing historic materials) and the addition of a new roof. The vestry is no longer at risk of collapse which would have brought down part of the medieval chancel.

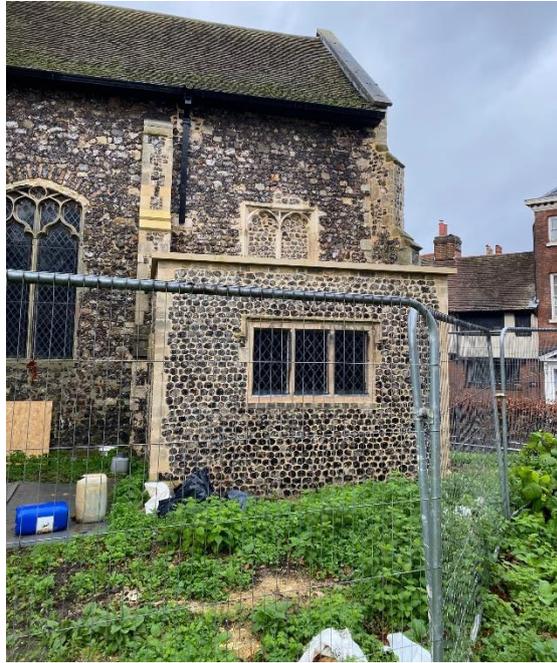
*General view of the completed vestry*

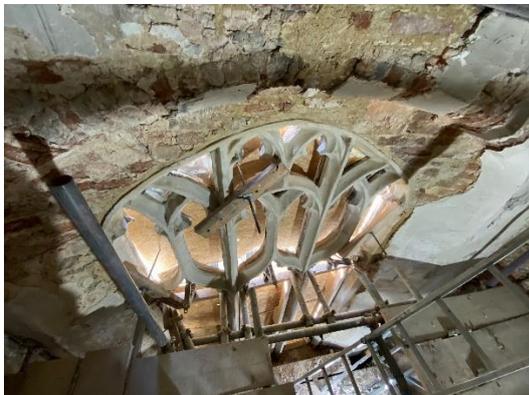
*Works to the inside of the south transept masonry*

Works to the ceiling of the north transept and general repairs to the south transept including the windows and poor stone work. Plaster repairs to the north and south transepts. These were previously unstable and causing risk to the church.

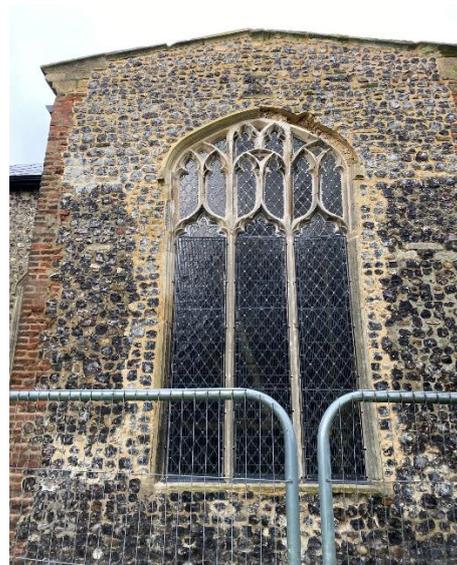
*Nearing completion of the repair to the south transept*

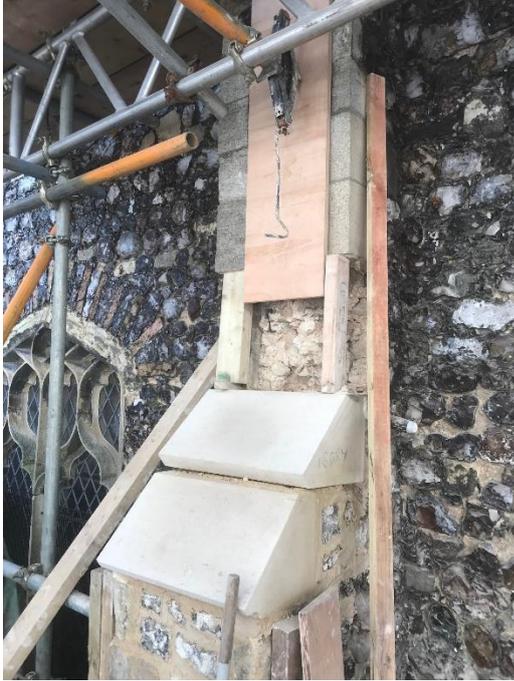
Buttress on south site under repair

Repair and new stonework to all buttresses. The chancel buttress was previously especially unstable.

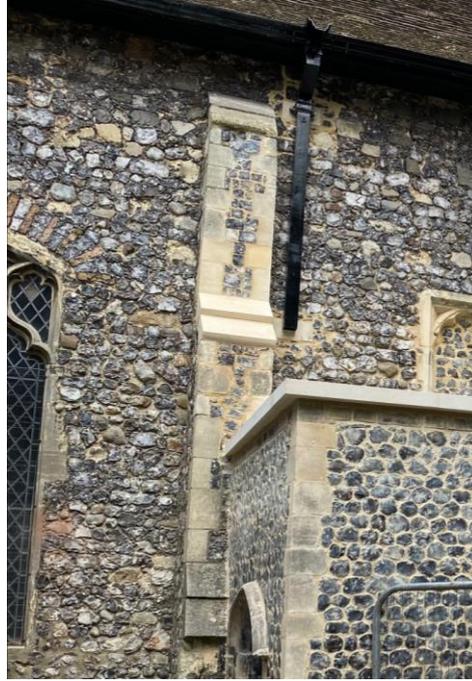
Completed buttress with new stone

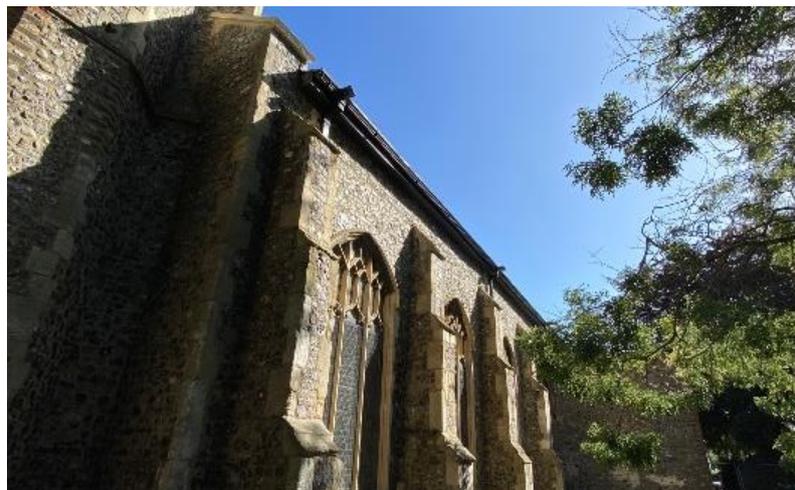
*Completed gutter renewal on south side of Nave*

Repairs to the roof's lead and the installation of new felt roof coverings. Repair and improvement of all rainwater goods (gutters and gullies) at roof level. Re-leading of the rood stair turret.

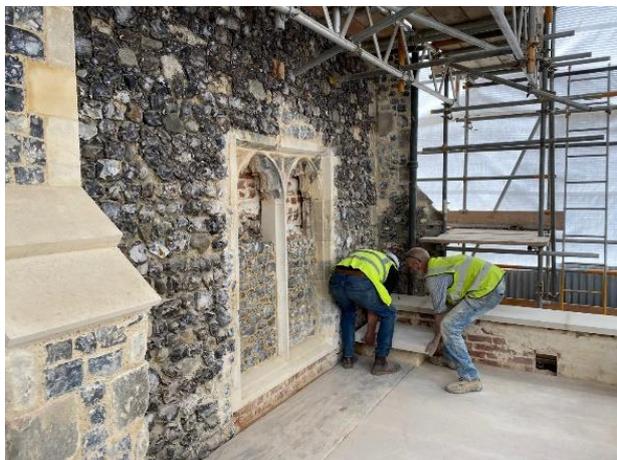
*New infill and stonework to the blocked chancel window*

General, extensive external masonry repairs including repair and stabilisation of window tracery. Flint repairs and renewal of the mortar using traditional techniques. Flint repairs offered opportunity for heritage skills training days using traditional hot lime mortar.

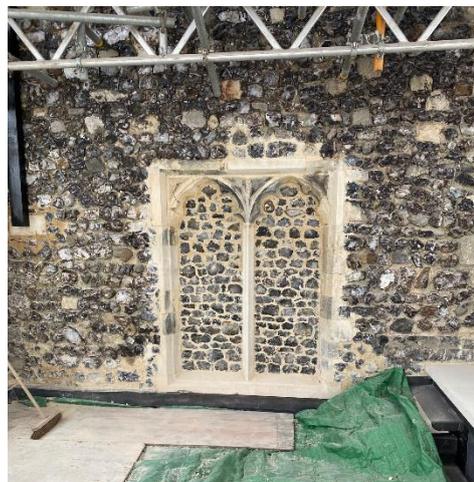
*View of completed Chancel window infill flintwork*

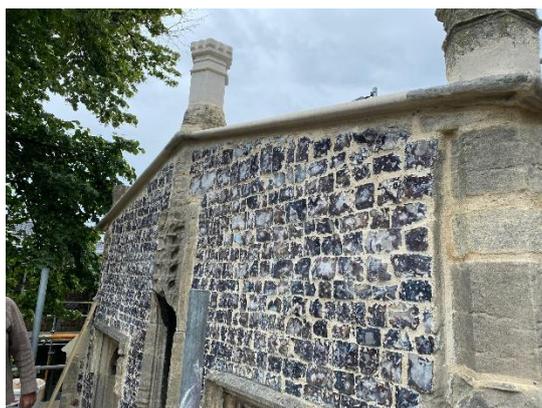
*Completed repairs to north porch*

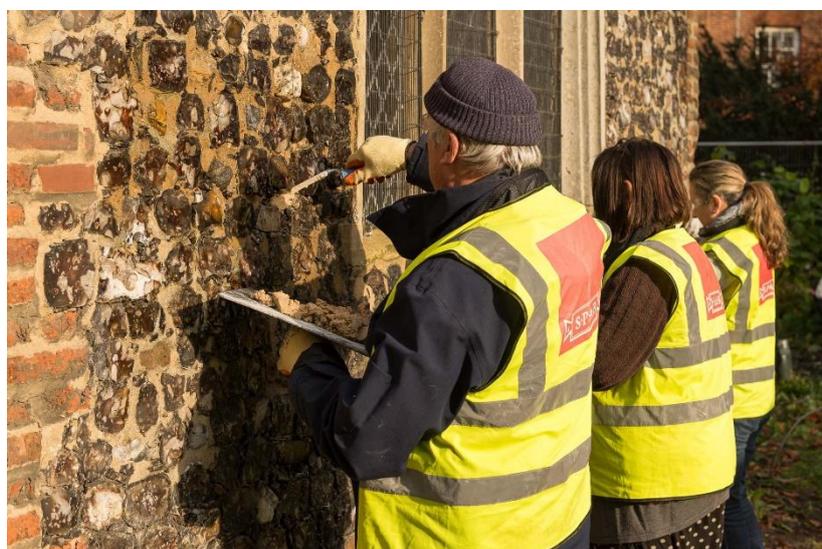
*Repair to flint mortar during a heritage skills training day*

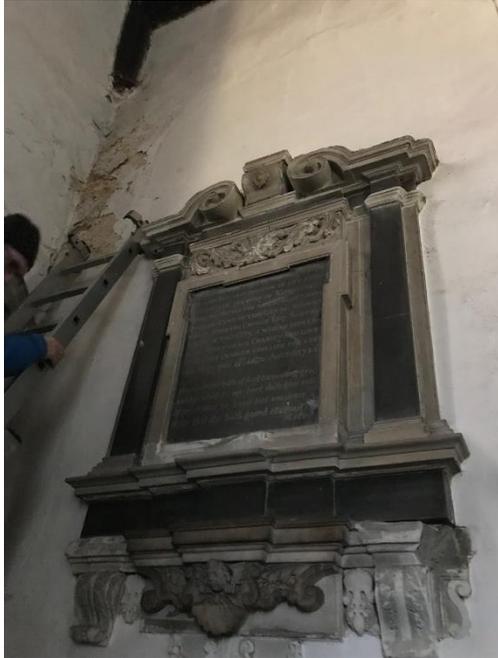
*Before works started on the internal wall monuments*

Reconstruction and repair to three internal wall monuments dating from the 17<sup>th</sup> and 18<sup>th</sup> centuries, as well as a conservation clean.

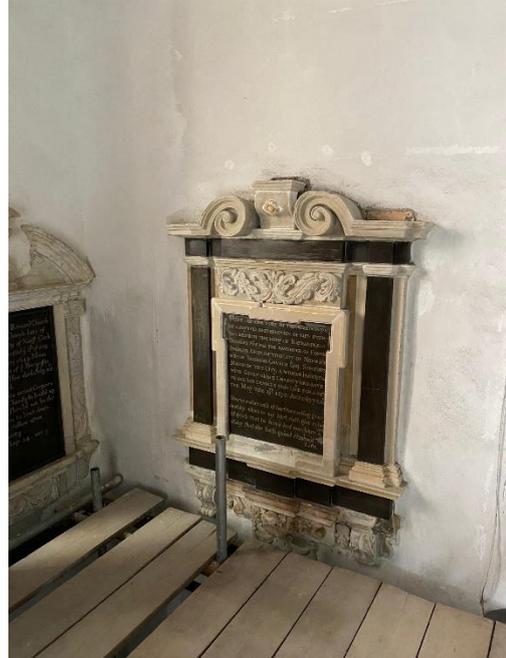
*Completed rebuild and clean of wall monument.*

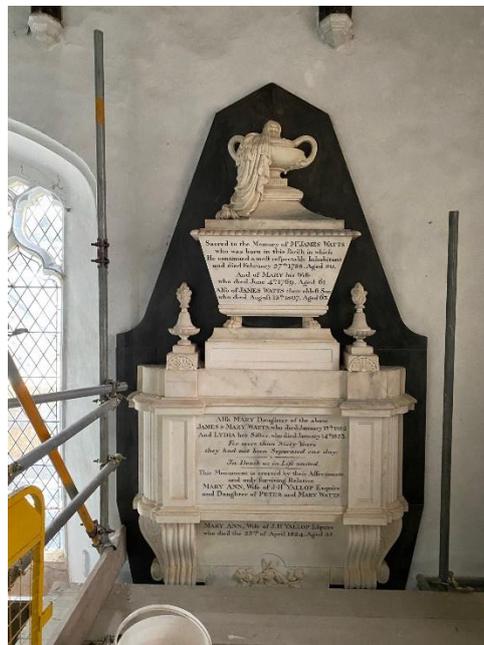
*Completed clean and repairs to wall monument on the North side of chancel*
