Snetterton All Saints

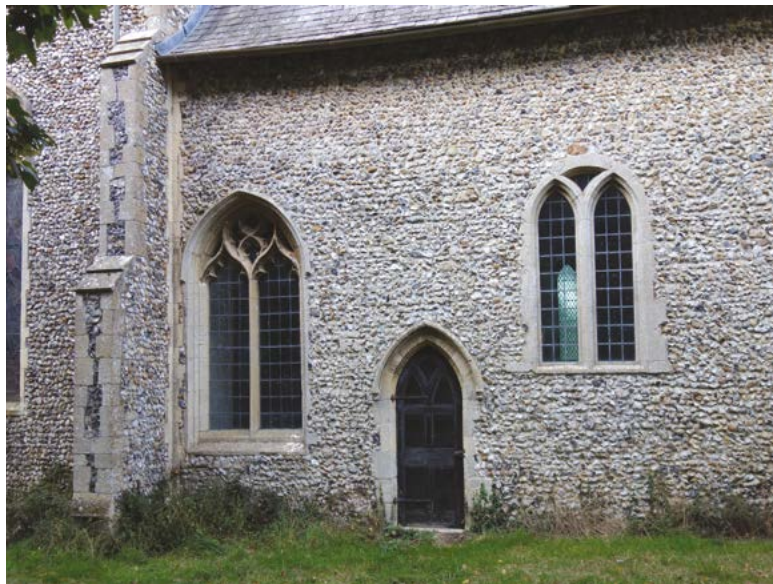
Figure 2. South side of chancel

Referring to the lithograph by Robert Ladbrooke in the 1820s, drawn from the southeast viewpoint, the south side of the Church has been altered, presumably during the restoration of 1852. His print shows the chancel with higher walls and a lower pitched roof, covered with lead, (now it has slates), above two high, narrow, rounded windows in the south chancel wall. As far as the lower part of the south chancel wall is concerned the openings seem much the same as now, with a two-light window of Decorated tracery at the south west end, then a priest's doorway, and the south east window has Y tracery of perhaps the 13th century. Nowadays there is no trace of the two upper windows, and the whole wall could have been re-faced. The tracery in the southwest window is very attractive with additional cusping within the quatrefoil in the apex.

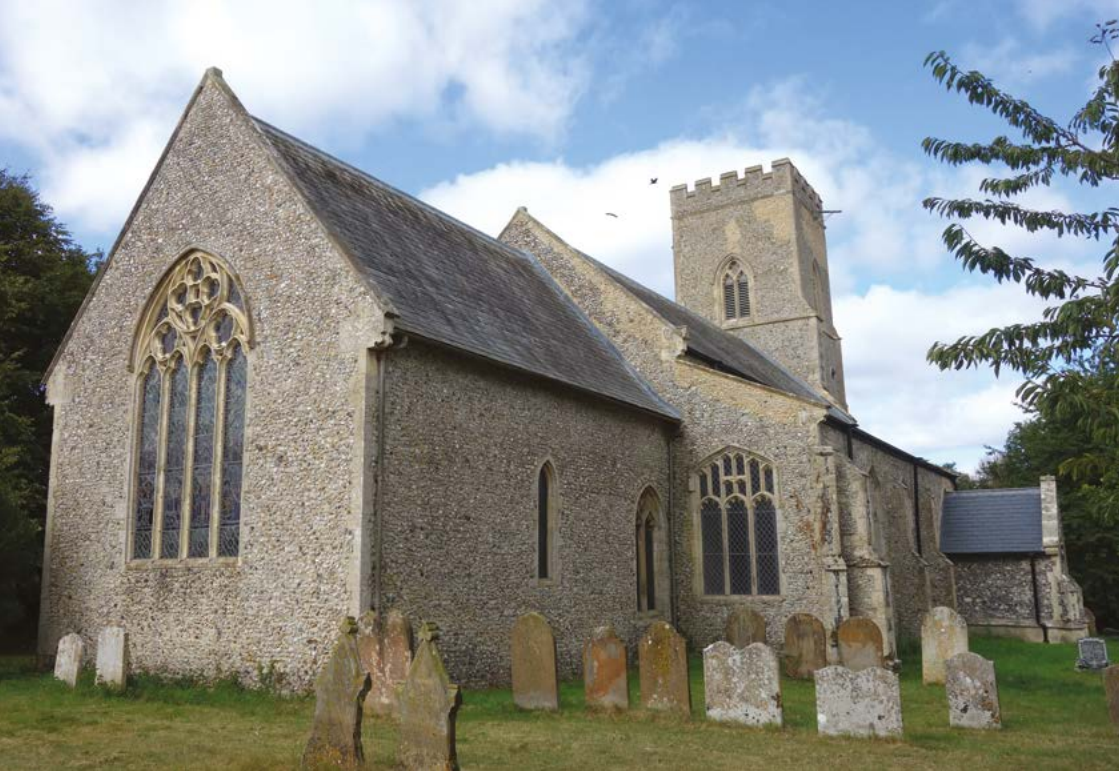
Figure 3: View from the north east

Approaching from the gate in the northeast corner of the churchyard, the **chancel** is the first thing to see. Its north wall is fairly blank, with a small 13th century lancet window half way along, and a Decorated 14th century window close to the west end.

The original late 13th century east window was replaced in 1852, and now has the Victorians' interpretation of Decorated tracery. It has in the apex a large stone circle containing four trefoils set in the shape of a cross. Below this are two cinquefoils in the stonework, and the four main lights have rounded trefoil heads.

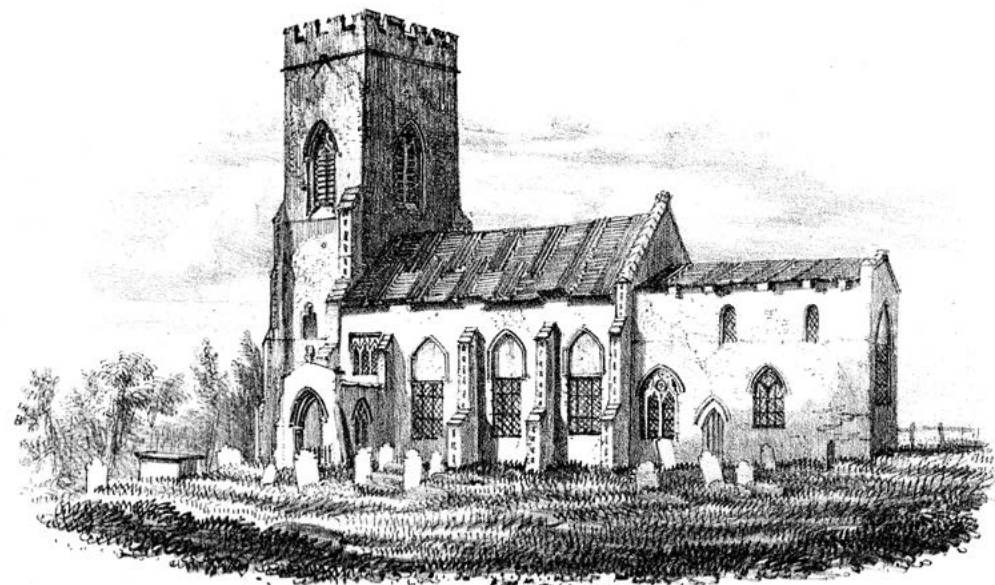
Figure 4: Ladbrooke, View of All Saints from the south east 1820's

style. When Robert Ladbrooke saw the Church in the 1820s the south nave windows were blocked at the top and no tracery was visible. He also depicted a lower **south porch**, (c. 1501) with a short square-headed three-light window above it. Now it has a steeply pitched upper storey, and a square stone panel enclosing a slate sundial above its entrance arch and has two small windows facing east and west. Both porches were altered as part of the remodelling between 1852 and 1854. Within the floor of this porch is the indent in a large stone, where once a brass figure had been set. It is unlikely that the stone is in its original position, and was perhaps moved here when the Victorians reordered the chancel. It appears to have held the figure of a knight in armour, perhaps from about 1500. The porch encloses a 13th century doorway of many mouldings right round the arch, with no capital.

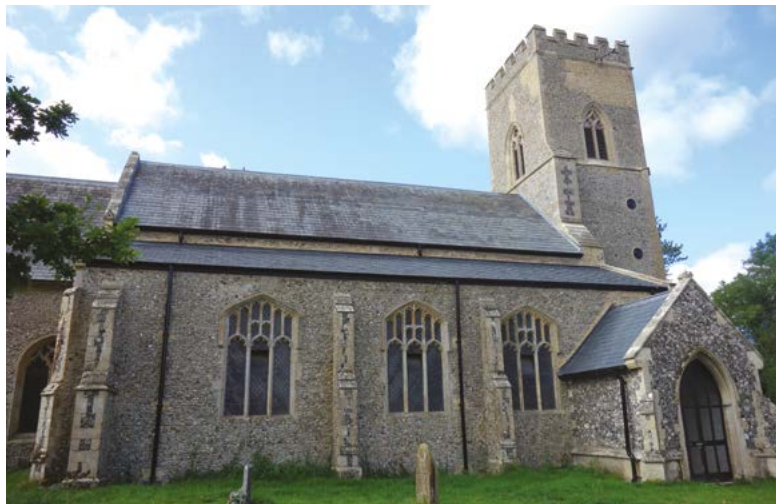
Figure 5: North aisle and porch after 2019 repairs

The Church was enlarged c. 1450 by the addition of a **north aisle**. Its three north windows have similar, but not identical tracery to those in the south nave. The arches at the tops of the main lights are slightly pointed (the south ones have rounded heads), and the windows are also a bit shorter, due to the lean-to roof of the aisle, and there is a similar window at the east end of the aisle. The aisle is now covered with slates, as are the nave itself and both porches. The north porch is plainer than the south one, with

no windows, and encloses an Early English doorway, with a simpler arch than the one over the south door. It was presumably re-used and moved northwards from the original nave wall when the aisle was added.

Thanks to a substantial Heritage Lottery Fund Grants for Places of Worship grant awarded in 2017, augmented by additional money from the Norfolk Churches Trust, it has been possible to carry out extensive repairs, particularly to the tower, north aisle and chancel arch. All of which were considered to be in a perilous condition and the church was put on the Historic England Heritage At Risk Register. This was confirmed when a large section of flintwork on the west wall of the north aisle fell to the ground in Autumn 2016. There followed a year of investigations before the actual repairs started in June 2018, however it was only when the scaffolding was up and closer inspection of

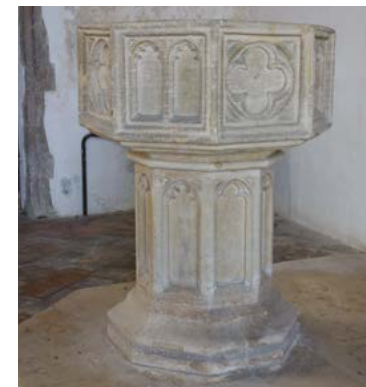
Figure 8: Font

The **15th century font** stands proudly on an octagonal plinth in front of the tower arch. Its eight sides have patterns of a quatrefoil within a circle on four sides, and a double panel with trefoil heads on the alternate sides. The stem has tall trefoiled panels.

The **font** dates from the late 15th century, with alternate panels of quatrefoils and two cinquefoil arches to the bowl. It stands on an octagonal plinth in front of the tall tower arch.

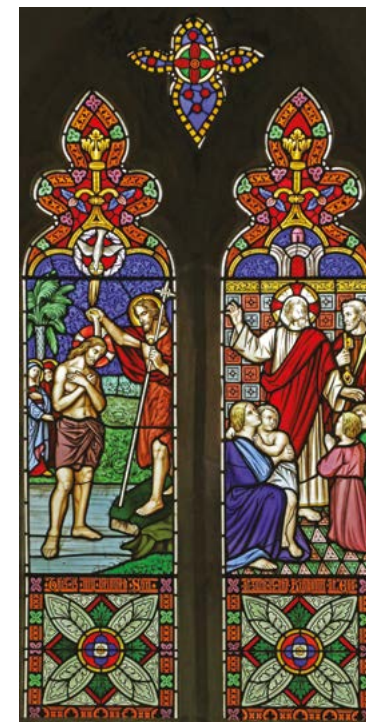
Figure 9: Tower window

The **tower arch** is very tall and quite narrow with polygonal capitals. Within the tower west wall is a colourful window containing stained glass donated by James Reeve of Snetterton Hall. It shows the Baptism of Jesus in the River Jordan by St John the Baptist, and Jesus saying "Suffer the Little Children to come unto me" and designed by Michael O'Connor and Sons, c. 1853.

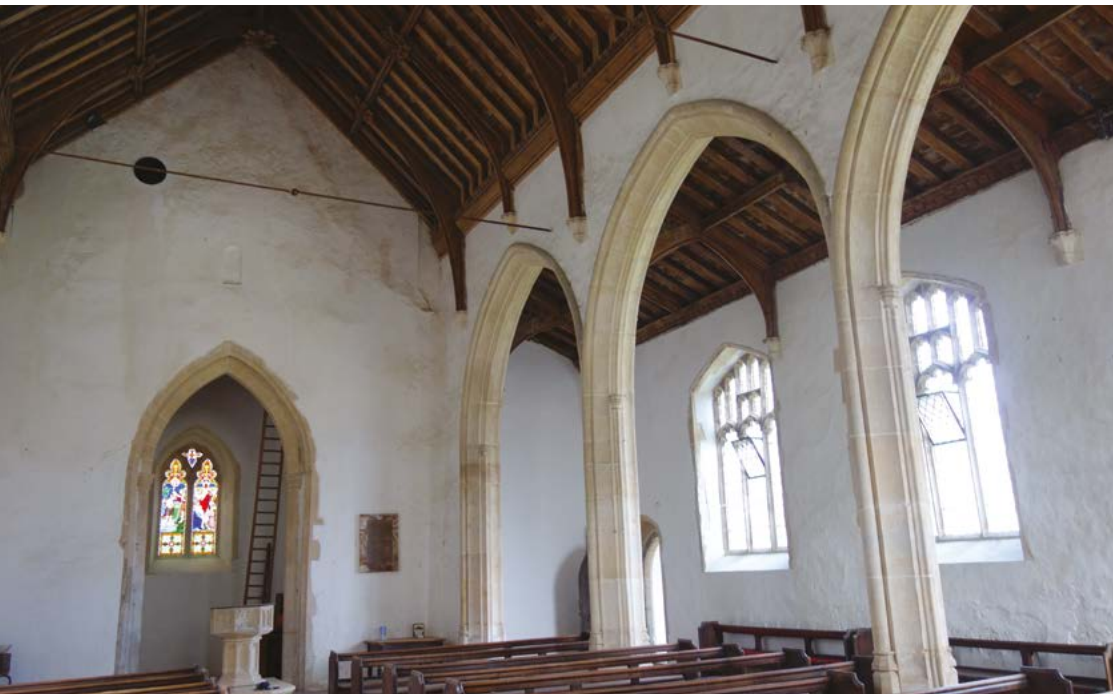
Figure 10: Interior to west

The arch-braced **nave roof** is supported by long wall posts on stone capitals with billet mouldings, and it has seven large decorative carved bosses all along the central ridge, and also along the purlins (the two other east/west rafters). These bosses are each carved with eight leaves, of slightly varying patterns, around a central carved knob, with half-bosses where these rafters meet the east wall. There are also wooden battlemented wall plates along the top of the walls.

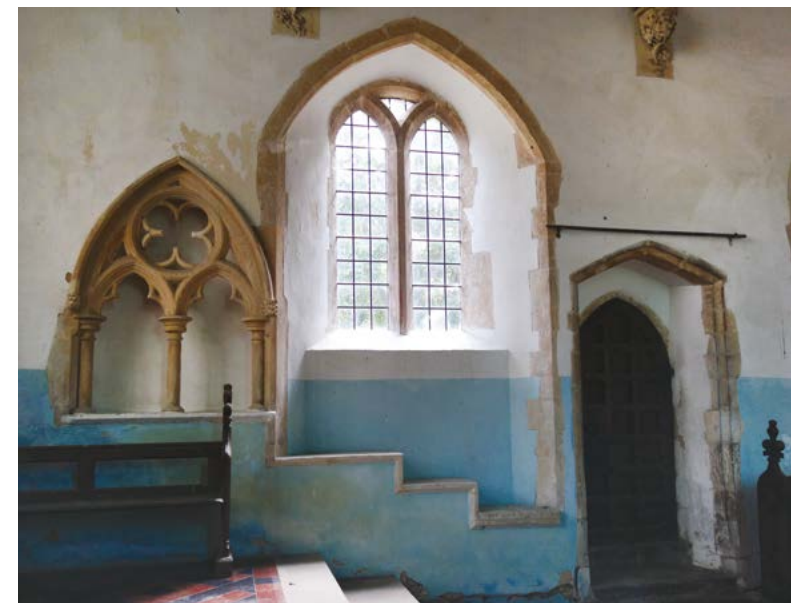
Figure 13: Chancel: Piscina, sedelia and priest's door.

Remaining from the second half of the 13th century is a particularly fine **double piscina**. The outer arch moulding ends in two fierce little heads, possibly lions, possibly demons. The inner arch has pierced tracery with a quatrefoil in a circle in the apex.

Below this are two arches, containing trefoil heads, supported on three shafts in the Early English style. There are two bowls with drains forming the piscina. During the reign of Edward I, (1272-1307), it was regarded as unseemly for the priest to wash his hands in the same bowl that had been used to cleanse the Mass vessels, the chalice and paten, so it became fashionable for a short time to have two bowls. Adjacent to this piscina is a **triple sedilia**, stepped to show the degree of importance of the three people who might sit there awaiting their part of the Mass Service - the priest, the deacon and the sub-deacon. The height of these seats indicates that they have nothing to do with the position of the present floor. Also in this south chancel wall is the **priest's doorway**. Traditionally the priest paid for the upkeep of the chancel, and he therefore had his own doorway to access his part of the church. The congregation had to maintain the rest of the building, the nave, aisles, tower and porches.

The **chancel** shows most signs of the Victorian restoration in the 1850s, with the altar elevated by three steps and the large east window filled with stained glass of that time. However, there is a fine double piscina, with two bowls, dating from the second half of the 13th century, and it has geometric tracery on three shafts. Its outer arch is supported by a lion's head on either side.
